# Memorandum

**National Highway Traffic Safety Administration**

Reporting of Information about Foreign Safety Recalls

Docket No. NHTSA-2001-10773

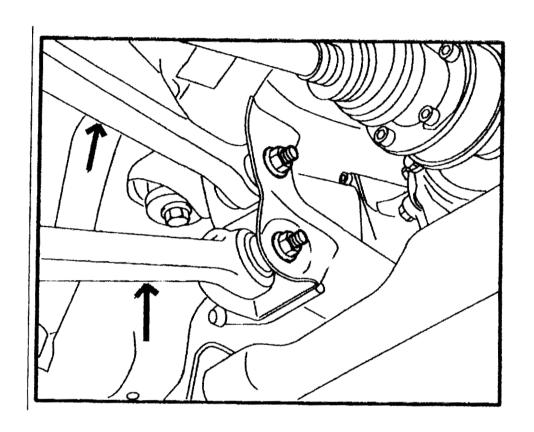
# Attachment A

> The defect involves the rear track control arms of Audi TT quattro (4-wheel drive) vehicles as shown in Attachment A. Moisture could enter the control arm's mounting bushing and bolt combination and cause corrosion Corrosion could impede the free movement of the control arm.

> Audi of America, Inc. will initiate a voluntary safety recall campaign instructing authorized Audi dealers to replace the affected track control arms. Notifications are anticipated as follows:

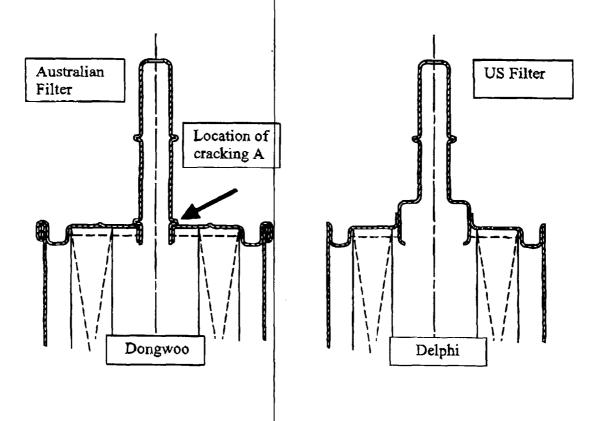
#### Filter Section:

The US Fuel Filter (Delphi) passed testing for bending/cracking. Under test conditions and maximum applied stress in the critical areas, the Fuel Filter remained undamaged and functional.
